Manhole Inspection Summary

Manhole # S33K__033MH

Inspection ☐ Is Incomplete Rating: **2) Good**

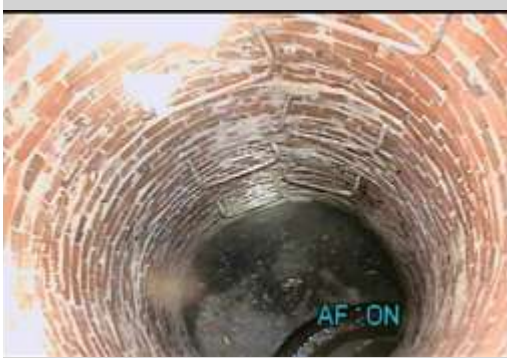
Defect 1

Steps Count: **7** Missing: **0** ☒ **Corroded**

steps

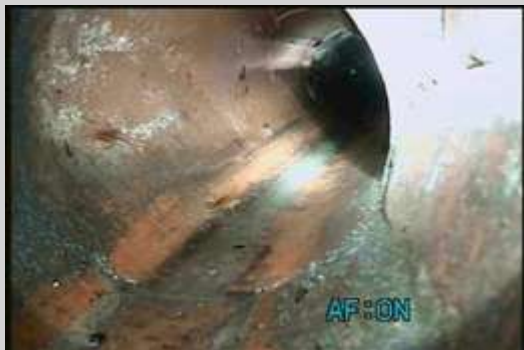
12 O'Clock Outflow

8 in. Circular Gravity Sewer
Pipe Out @ 12 O'Clock

Invert Depth: **11.98** (ft.) Flow Characteristics: **None**

Deposits: ☒ None ☐ Mud ☐ Sludge ☐ Debris ☐ Grease

Infiltration: **None** Pipe Seal Cond: **Unknown**

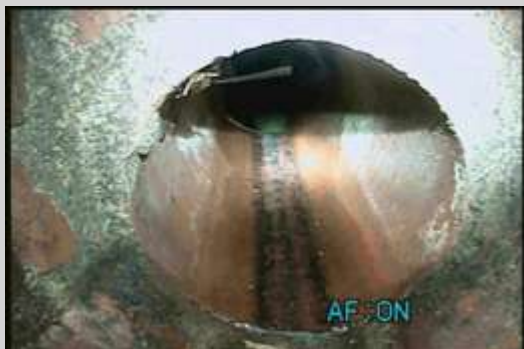
3 O'Clock Inflow

8 in. Circular Gravity Sewer
Pipe In @ 3 O'Clock

Invert Depth: **11.80** (ft.) Flow Characteristics: **None**

Deposits: ☒ None ☐ Mud ☐ Sludge ☐ Debris ☐ Grease

Infiltration: **None** Pipe Seal Cond: **Unknown**
